OHIO RIVER BASIN,
JACOBS CREEK, WESTMORELAND COUNTY, Pennsylvania

PA-657 DAM
(ACME DAM)

PHASE I INSPECTION REPORT,
NATIONAL DAM INSPECTION PROGRAM

Owner: Westmoreland County Commissioners
State Located: Pennsylvania
County Located: Westmoreland
Stream: Jacobs Creek
Inspection Date: 4 May 1979
Inspection Team: GAI Consultants, Inc.
570 Beatty Road
Monroeville, Pennsylvania 15146

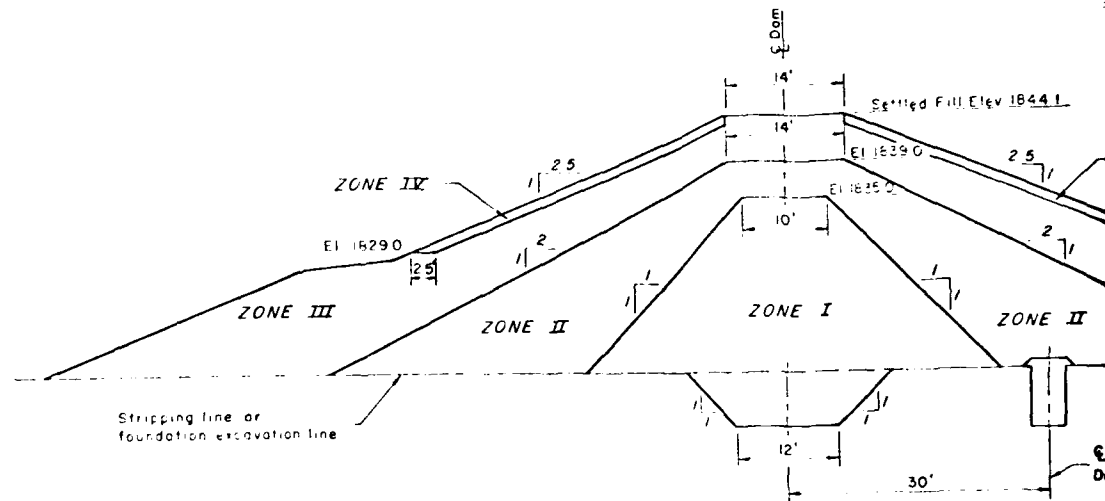
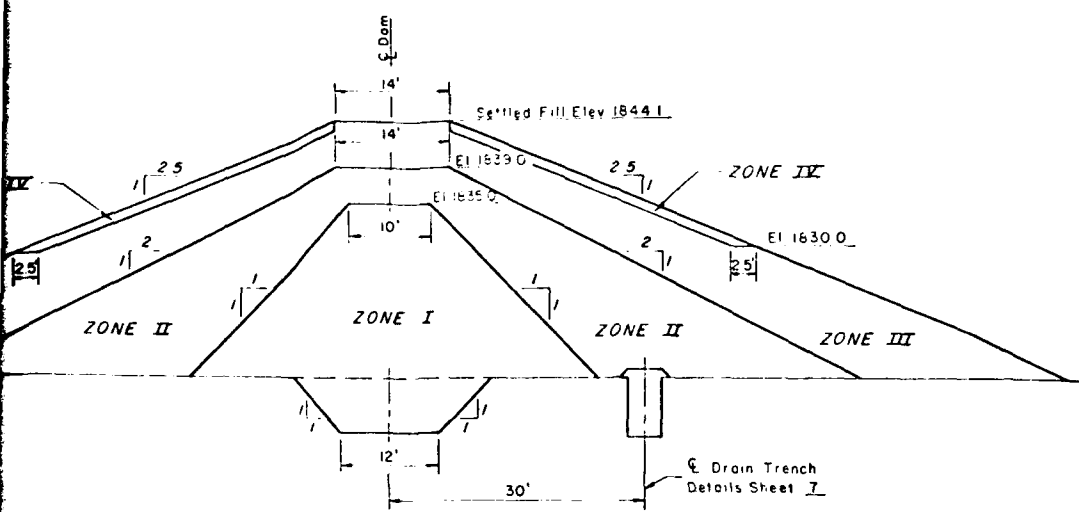
FIGURE 4

b. Design Features. Available construction drawings and design data indicate that the dam is a zoned earthfill structure consisting of approximately 26,000 cubic yards of fill. The structure is comprised of four zones as shown in Figure 4.

a. Embankment. Based on visual observations, the embankment appears to be in good structural condition. No evidence of seepage or structural deficiencies were detected during the inspection. Some minor erosion was observed along the upstream embankment face directly behind the service spillway riser. Conversations with the local SCS representative, who accompanied the field team during the inspection, revealed that no riprap was placed along the upstream slope as the material comprising the outer shell (Zone III) was considered sufficiently coarse and did not warrant further protection. It is noted that the Zone III material was covered with topsoil (Zone IV) and the erosion, as observed, may be confined to the Zone IV layer (see Figure 4). Nevertheless, the condition should be assessed and corrected if necessary.
